St. Margaret's Church

I P S W I C H

Evidence of Medieval Wall Paintings in the church

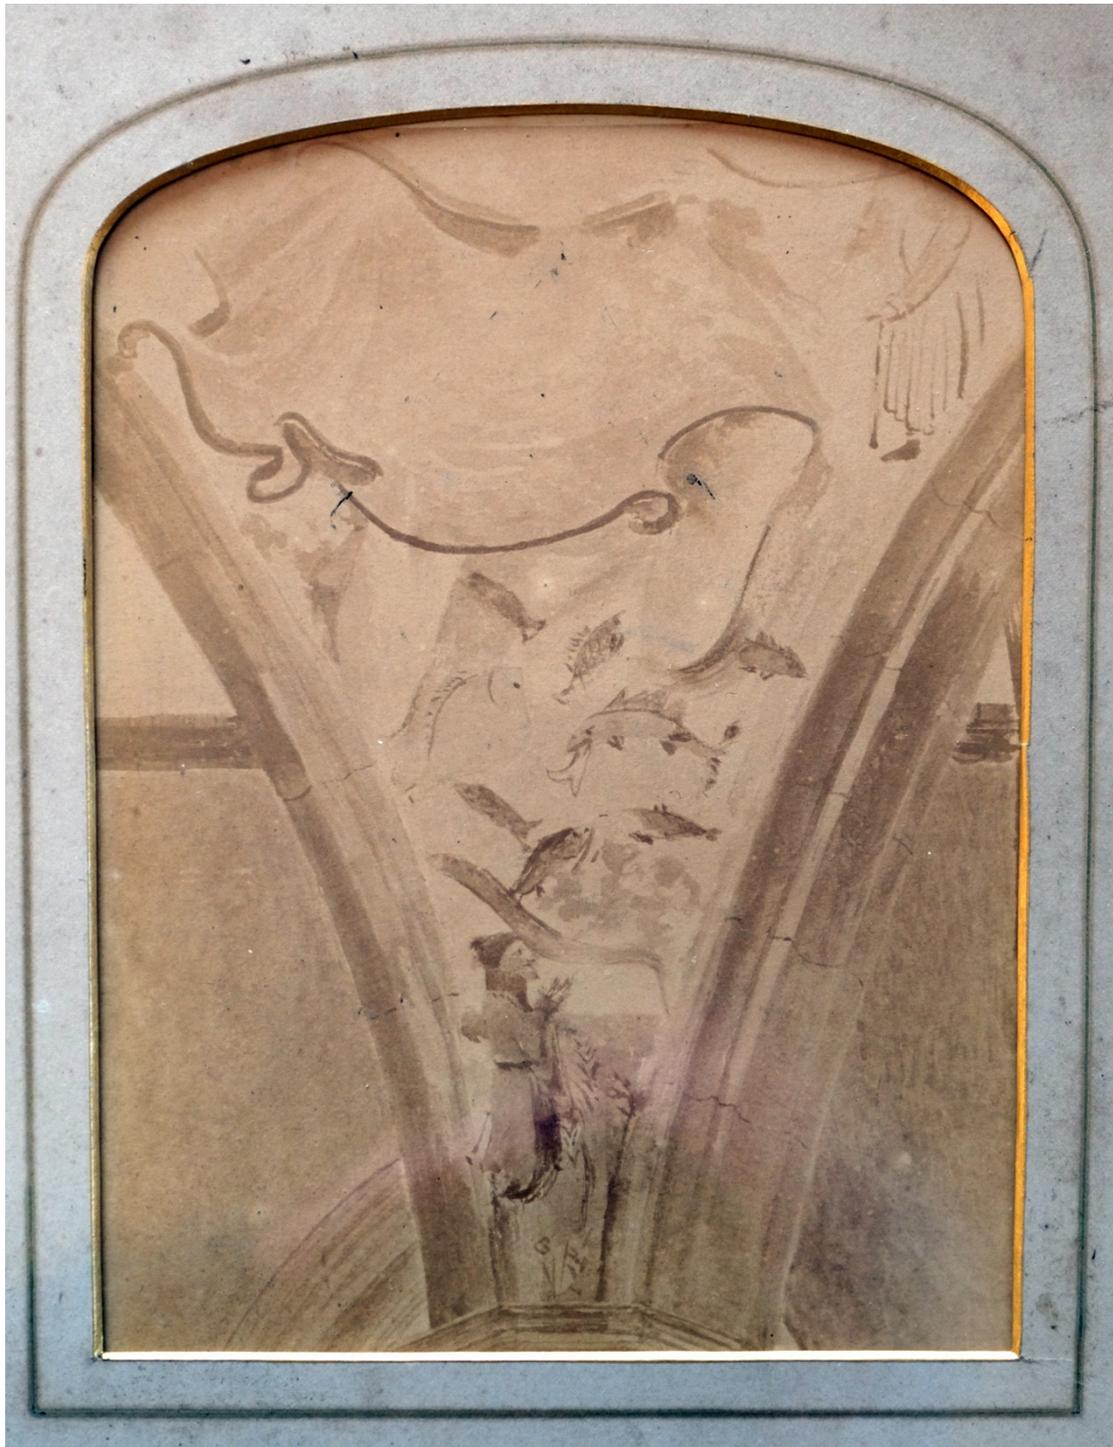
The following photograph (of an early photograph of a painting) shows the wall painting as it appeared in 1872

Photographed from a watercolour painted by Rev Augustus Gedge, Rector of Ludborough Lincs, soon after it was discovered. St Christopher's gown was pink. That of the monk at bottom, if I remember rightly, was dark green. Presented to St Margaret's Church by Rev Arthur A L Gedge son of the above Jan 7 1931. The fresco was between two of the arches on the north wall. A.A.L.G.

It is clear that the photograph and, before that, the watercolour may have deteriorated over time and we can be certain that the colour shown here is not representative of that which was seen on the wall.

What can be seen is the lower part of St Christopher's cloak as he strides through the water with fish and eels at his feet. There is no sign of any text.

In 1846 above the second and third arches (from the east end of the church) on the north side of the nave, a wall painting of part of St Christopher was uncovered. This was whitewashed over in 1881 and was again visible for a short time when the hatchments were moved during the conservation of the roof in 1994. The position of the painting can nowadays be judged as it lies under the westernmost hatchment on the north nave wall.

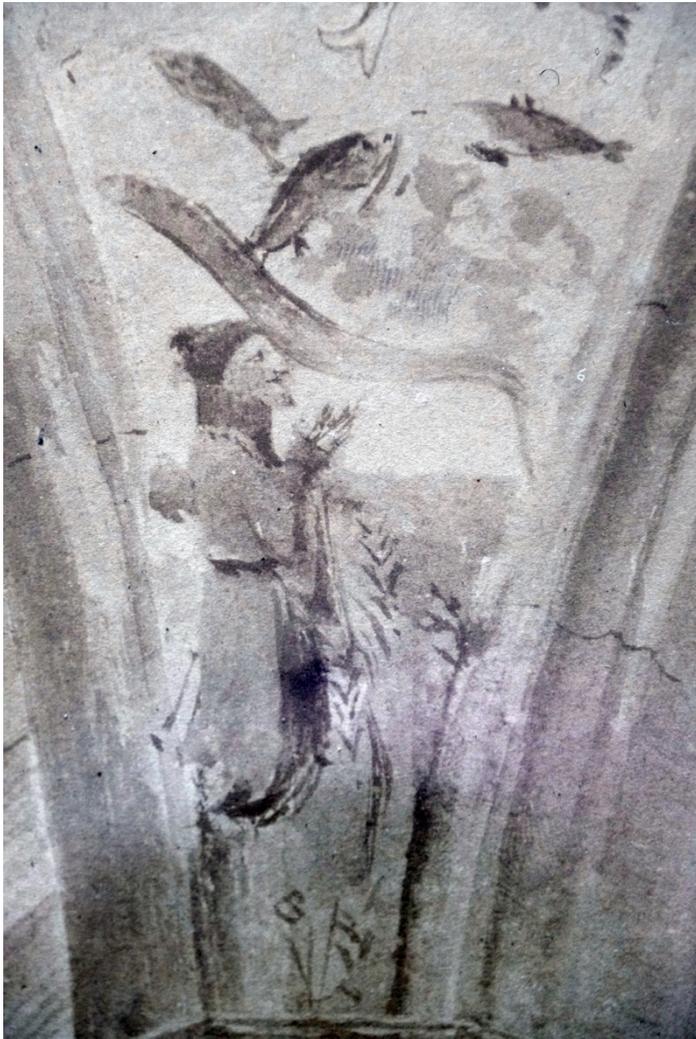
The photograph above was taken from the larger picture and digitally enhanced to show more clearly the figure at the foot of the picture, previously said to be of St Anthony.

A more recent review of the photograph postulates that the person kneeling is not St Anthony. The figure is small and of a lay person, thus showing their humility and insignificance. It is suggested that the figure represents the hermit, a frequent subject appearing with St Christopher. St Christopher, on his quest for "the greatest prince on earth", finally met a hermit who preached Christ to him and instructed him in the Christian faith. It was the hermit who directed St Christopher to the river to help people cross safely. St Christopher built a shelter and there on one occasion carried Christ, who appeared as a child, across the river.
